Solubility of limestone and seepage problems in the left abutment of the Marun dam, southwest of Iran

M.H.Ghobadi: Bu-Ali Sina University,
Geology Department,
R. Karami: Shahid Chamran University,
Geology Department, Ahvaz

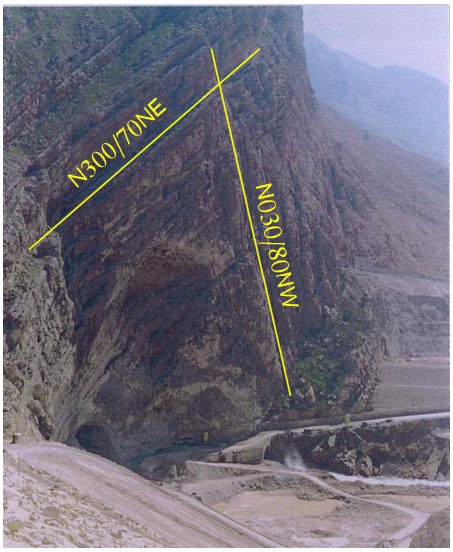
Fig.8. Several joint sets cut the Asmari limestone at the site. The rock mass is cut by two major sets of joints. One major joint set strikes 030 and dips 80 degree NW. The other major joints set strike 300 degree and dips 70 degree NE.
